Long-term durability of silicone breast implants

Aim: The purpose of this study is to investigate the deformability and strength of silicone breast implant shells from different manufactures as a function of implantation time.

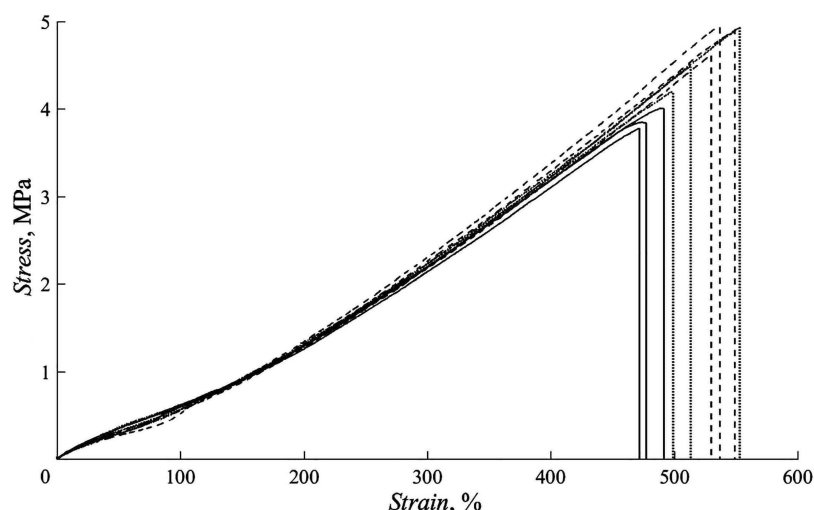
Figure 1. Stress-strain curves for the Eurosilicone implant shell after 8 years of use. The graph shows the stress-strain curves of three different shells with three samples each

In order to plot general strength graphs for implant shells at different times of their stay in the body, the minimum tensile strength values were used. Although the stress-strain curves are the same, within the margin of error, for the same type of breast implant shells (Figure 1), their rupture behavior differs greatly, which is attributed to the fact that the shell thickness varies slightly in different areas. Just these minimum values are the areas of interest for researchers and users because the implant breaks exactly at the points where the shell is weak and thin. In addition, microdefects are known to accumulate during the whole life cycle of breast implants [3, 23]. Besides, microdefects are unevenly distributed throughout the examined area, and the accumulation of defects proceeds faster exactly in a thinner cross-section of the shell.

It was found that, within the margin of error, the stress-strain curves are similar for breast shells of the same type and with the same implantation time (Figure 1), but they have large differences in their rupture behavior. This is due to the fact that the thickness of a breast shell varies to a certain extent in different regions of the shell. The most complete information on the strength of implant shells as a function of time was collected for Eurosilicone implants (Figure 2), and the less amount of data were obtained for the Mentor (Figure 3) and Motiva (Figure 4) implants, which were used for a short time. Several tests were conducted on the Allergan (Figure 5), Arion (Figure 6), and PIP (Figure 7) implant shells. Since the shells were subjected only to individual tests, the graphs for these shells are compared with the curves plotted for the Eurosilicone implant shell with the same breast implant life cycle.

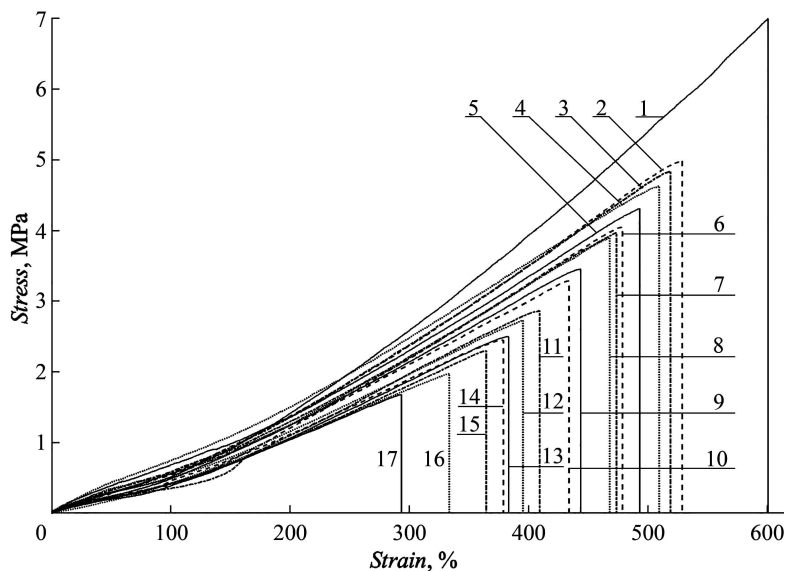
Figure 2. Stress-strain curves for the Eurosilicone implant shell at different times of implant stay in vivo. 1—control, unused implant; 2—6 years; 3—6.5 years; 4—7 years; 5—8 years; 6—9 years; 7—9.5 years; 8—10 years; 9—11 years; 10—12 years; 11—13 years; 12—14 years; 13—15 years; 14—15.5 years; 15—16 years; 16—17 years; 17—19 years

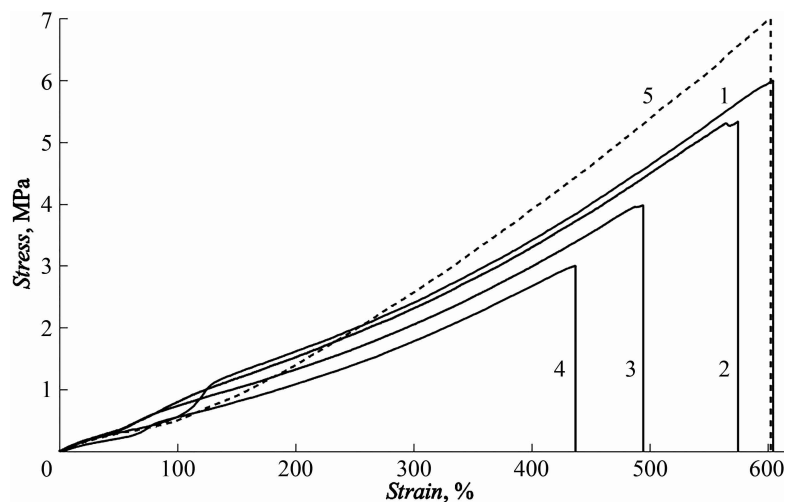
Figure 3. Stress-strain curves for the Mentor implant shell at different times of implant stay in vivo. 1—1 year; 2—3 years; 3—8 years; 4—11 years; 5—control Eurosilicone implant shell

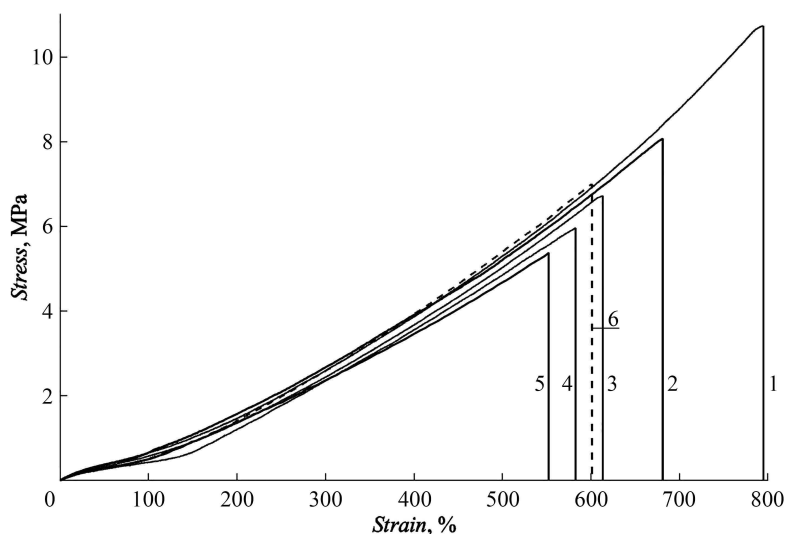
Figure 4. Stress-strain curves for the Motiva implant shell at different times of implant stay in vivo. 1—control, unused implant; 2—6 months; 3—1 year; 4—1.5 years; 5—2 years; 6—Eurosilicone control, unused implant

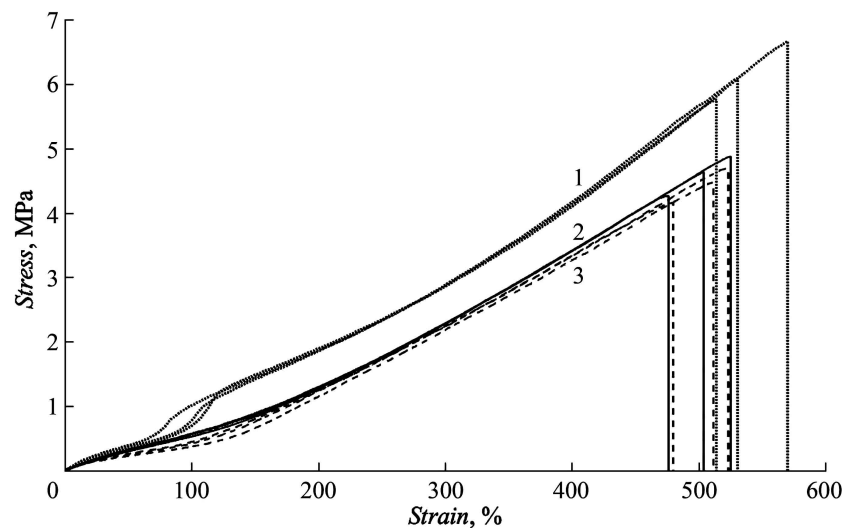
Figure 5. Stress-strain curves for the Allergan implant shell in comparison with other implants. 1—Mentor (9 years); 2—Allergan (9 years); 3—Eurosilicone (9 years). Three independent tests are given here for each material

As shown in Figure 5, the Allergan shell (0.75–0.93 mm thick) is almost identical in mechanical properties to the Eurosilicone shell after 9 years of use. The Mentor implants exhibit greater strength and stiffness.

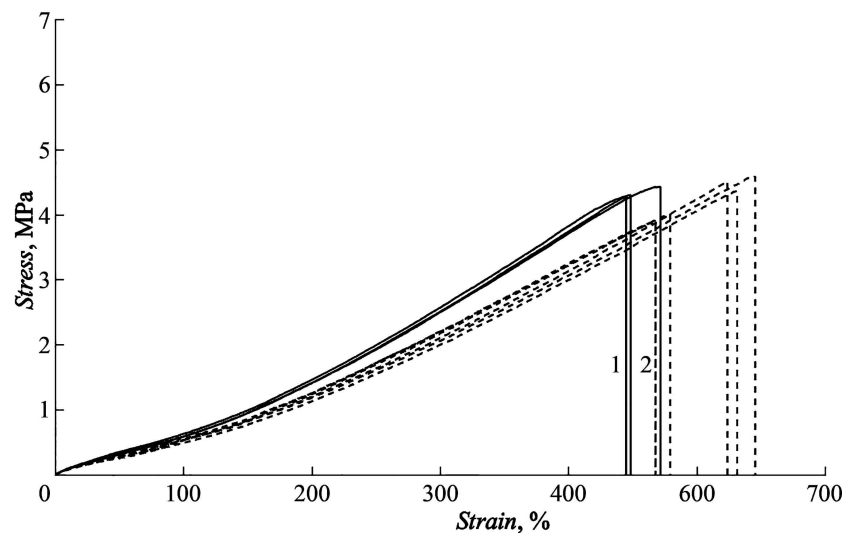
Figure 6. Stress-strain curves for the shells of the Arion (10 years) and Eurosilicone (10 years) implants. 1—Arion (three tests); 2—Eurosilicone (five tests)

The 0.81–0.97 mm thick Arion implant (Figure 6) after 10 years of use appears to be slightly more rigid and withstands a higher breaking force than the Eurosilicone implant, but the Arion implant has less risk of rupturing.

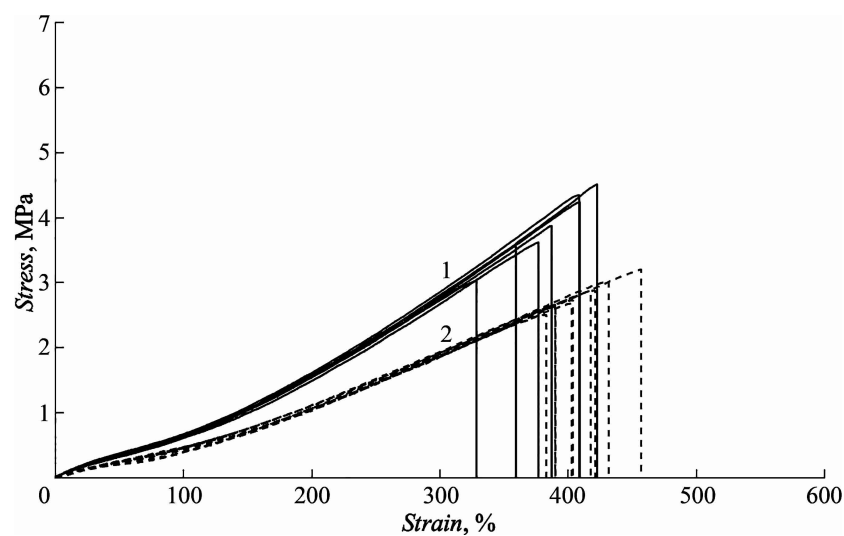
Figure 7. Stress-strain curves for the shells of the PIP (15 years) and Eurosilicone (15 years) implants. 1—PIP; 2—Eurosilicone. Shown here for each material are graphs of seven independent tests that were tested with multiple PIP and Eurosilicone shells at different times

The stress-strain graphs of the PIP implant shell tests after 15 years of use demonstrate significantly higher strength and stiffness than those of the Eurosilicone implants. However, the rupture strains of these implants are much smaller.

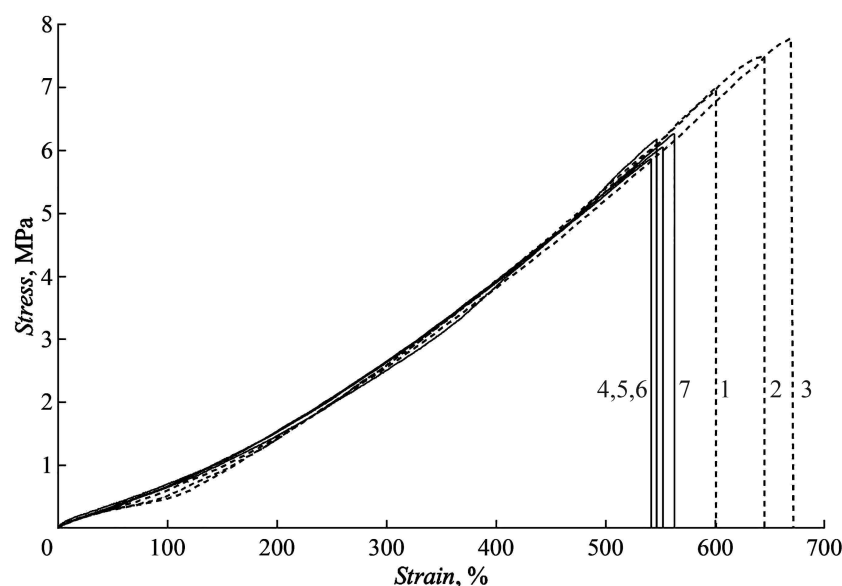
Figure 8. Stress-strain curves for the Eurosilicone shells. 1, 2, 3—control Eurosilicone implant; 4, 5, 6, 7—Eurosilicone after 6 days of use

Finally, a series of tests were conducted on the shell of the Eurosilicone implant, which stayed in the body only for 6 days and was removed for medical reasons (Figure 8). In contrast to the control, the unused specimen made of this material, the obtained results demonstrated a weakening in the mechanical properties of this shell. Most likely, this can be attributed to the accumulation of microdamage in the implants, which were deformed during the surgical procedure for inserting and positioning breast implants and their subsequent removal.
